# Multiple type IV stent fractures resulting in an in-stent restenosis and coronary aneurysm formation – a dark side of “full-metal jacket” stenting

Adv Interv Cardiol 2024; 20, 2 (76):  
DOI: <https://doi.org/10.5114/aic.2024.139631>

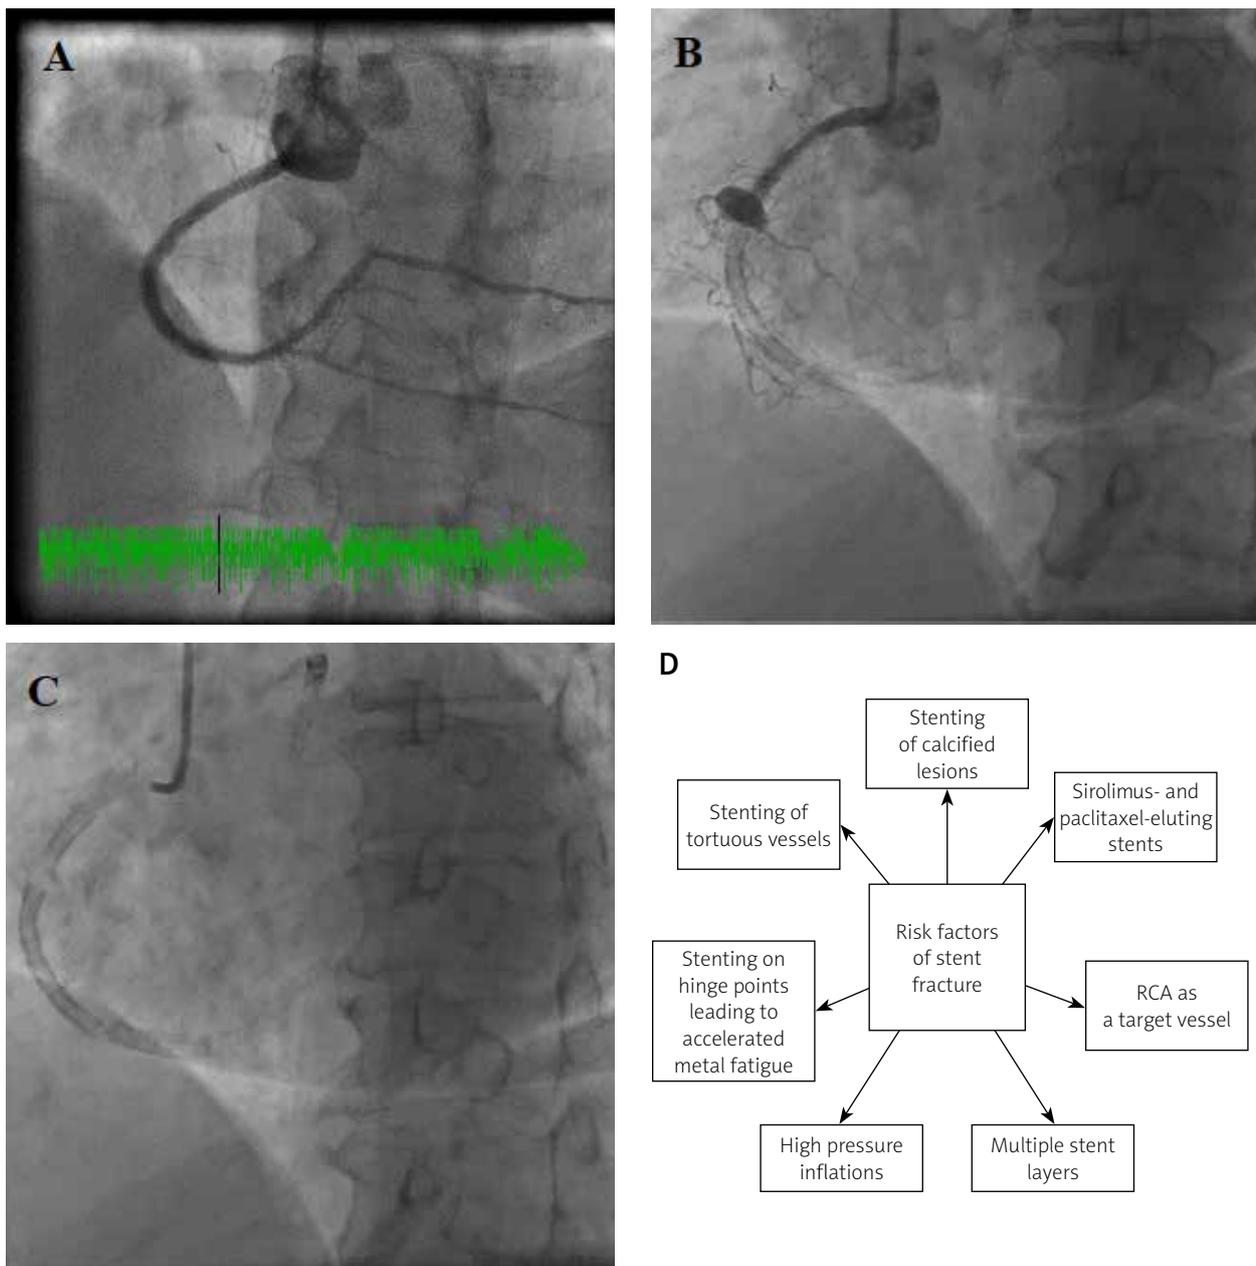
A 63-year-old female patient was scheduled for an elective coronary angiography due to stable angina symptoms. Prior to the present admission, she had undergone 5 percutaneous coronary interventions (PCI) of the RCA, including repeated procedures for ISR (Figure 1 A). All the procedures were finished with stent implantation without intravascular ultrasound (IVUS)/optical coherence tomography (OCT) guidance, and no drug-eluting balloon (DEB) was used. This resulted in the so-called “full-metal jacket” with multiple layers of overlapping stents. The present coronary angiography revealed a multifocal type IV SF (a complete transverse fracture with displacement), chronic total occlusion (CTO) of the RCA, and coronary aneurysm formation at the level of the fractured stent (Figures 1 B, C). Furthermore, it demonstrated a significant lesion of the left circumflex coronary artery (LCx) which was responsible for the patient’s symptoms. PCI of the LCx was performed, while for the vessel with SF the watch-and-wait strategy was chosen. The patient was scheduled for a follow-up evaluation after 6 months

**Figure 1.** **A** – Angiography of the right coronary artery 13 months prior the present admission; **B** – Coronary angiography demonstrating an aneurysm of the right coronary artery with a chronic total occlusion of the vessel and 3 stent fractures (at the level of the aneurysm; on the border between second and third segment of the vessel; and in the distal portion of the vessel); **C** – The so-called “dry cine” image demonstrating stent fractures; **D** – Risk factors of stent fracture

with multislice CT and/or coronary angiography, and in case of the progression of the aneurysm, a percutaneous (implantation of a covered stent or stent-assisted coil deployment) or surgical closure will be considered. In the case of refractory angina with evidence of viable myocardium in the RCA territory (last echo showed akinesis of the RCA regions), PCI of the CTO (e.g. DEB-only PCI) could be considered. The decision will be made after weighing the pros and cons of these strategies in a shared-decision making process with the patient and the Heart Team.

There are several risk factors of SF, i.e. stenting of RCA, longer stents, overlapping stents resulting in hinge movements, stenting of calcified lesions, high pressure deployment, and sirolimus- and paclitaxel-eluting stent implantation [1–3] (Figure 1 D). SF can be diagnosed with the use of intravascular imaging modalities, multislice CT, and sometimes by enhanced stent visualisation software tools (e.g. StentBoost or ClearStent) [4]. In the present case, SF was apparent on ordinary cine angiography without using high-resolution software protocols.
